Management Report

Site Overview

Total Sections: 1
Total Sq/Ft: 60,103

Inspection Date: 02/24/2020

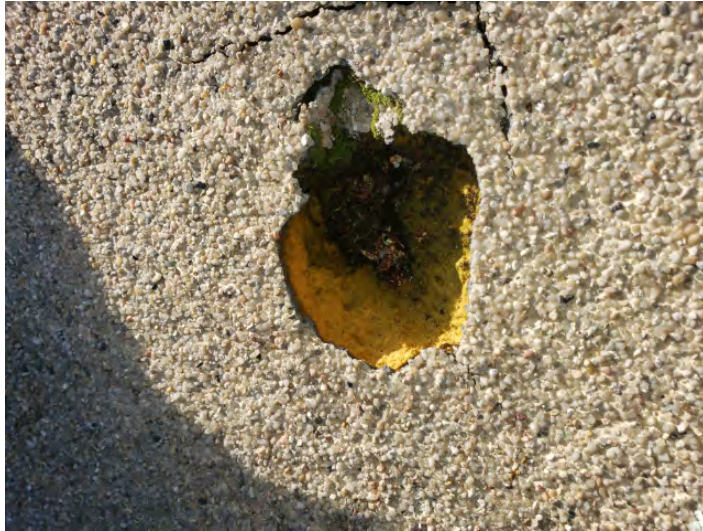
Puncture
Tectum
Spray Foam w/ granules

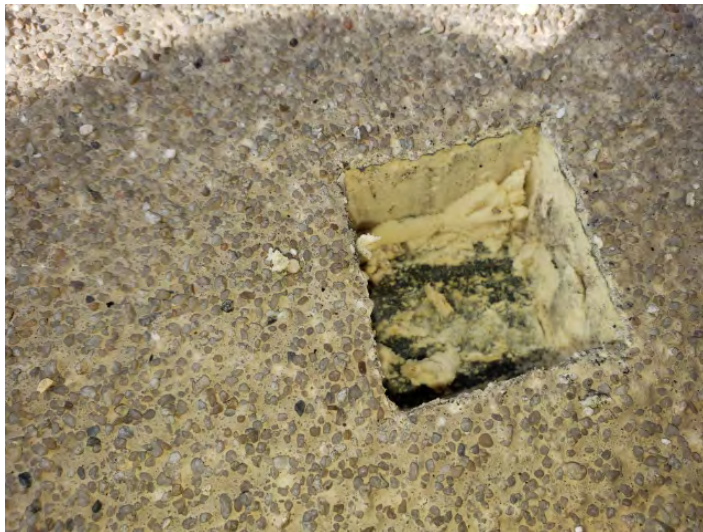
cut 1
plywood
1.5" foam w/ granules

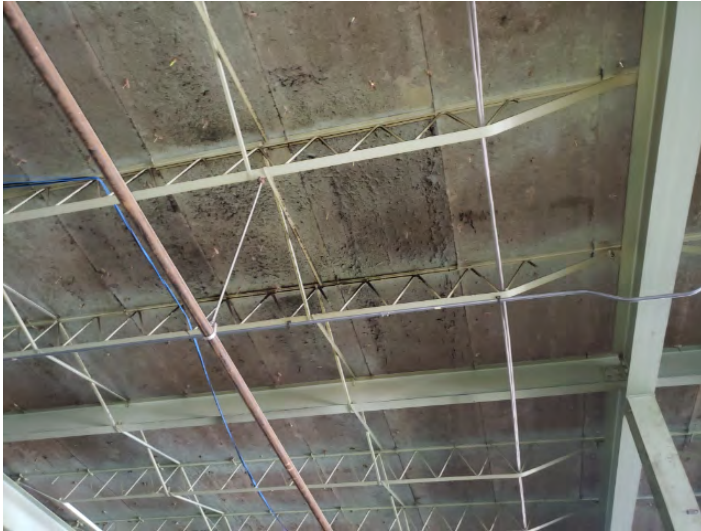
Inside view of deck
Tectum

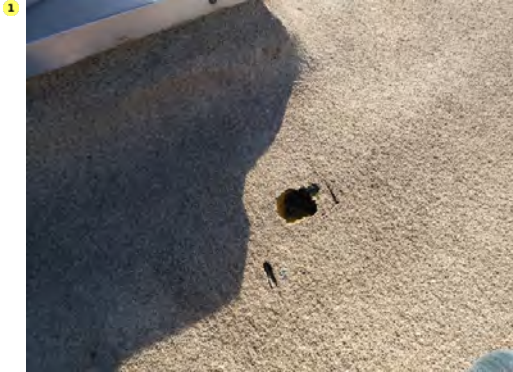
General - (Remedial)

Punctures and/or erosion allowing water in the roof system.

With this type of roof system there is nothing permanent we can do to patch the puncture/erosion. We can caulk with silicone which is a temporary repair.

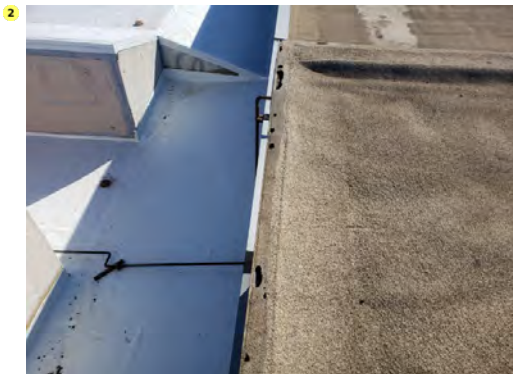
General - (Remedial)

Punctures/ Erosion around perimeter of the roof.

With this type of roof system there is nothing permanent we can do to patch the puncture/erosion. We can caulk with silicone which is a temporary repair.

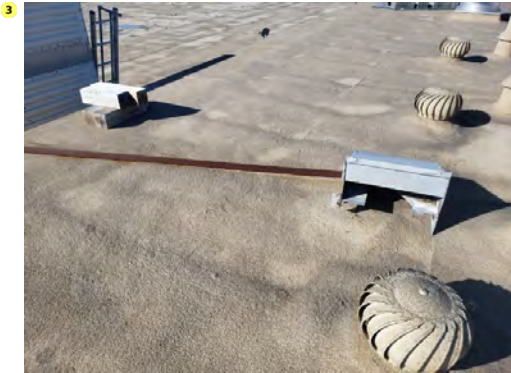
General - Debris (Remedial)

Debris on roof. It is recommended that you do not have debris loosely laying around on the roof without slip sheets or being tied down. They could cause damage or injure someone.

Remove debris off roof and dispose of properly.

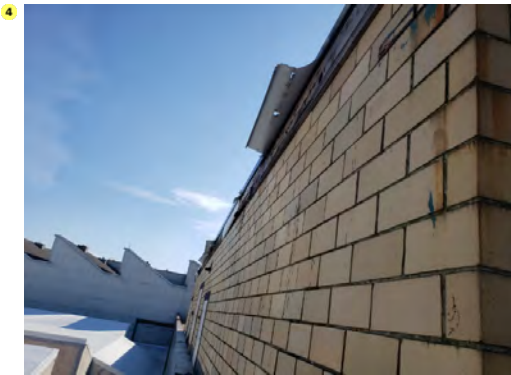
General - Fascia metal loose (Remedial)

Fascia metal blowing off, damaged and loose.

Remove what fascia metal that is hanging there and damaged. Install new fascia metal.

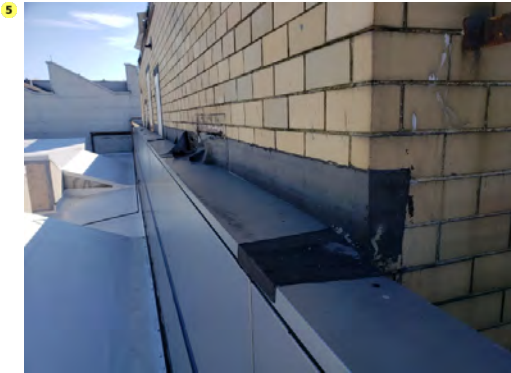
EPDM - Coping / Wall Flashing Open (Remedial)

Coping joints and wall flashing is open allowing water into the system.

We will clean and seal open coping joints and wall flashing. You would need to utilize ladders, ladder jacks and a walk plank to do this repair. As well as a lift to get tools and material on the roof. The men will have to be totally tied off per MOSHA.

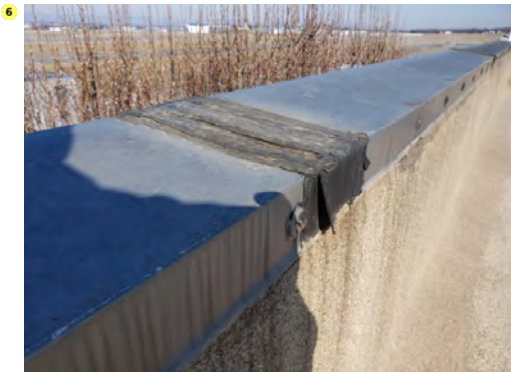
EPDM - Coping / Wall Flashing Open (Remedial)

Coping joints are open and allowing water in.

We will clean and seal open coping joints.

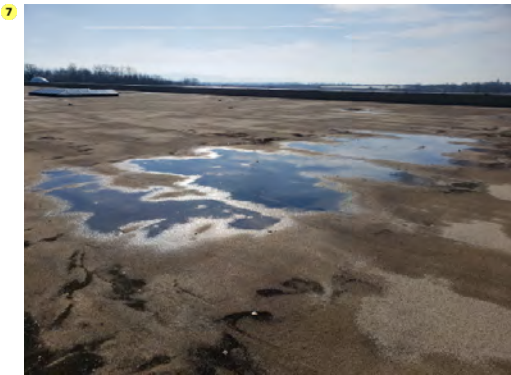
General - Ponding (Remedial)

A ponding water condition is typically due to a flaw in how the original roof was designed to flow to drains or the underlying insulation has collapsed due to age or weight and created a low lying area on the roof which is now holding water.

A ponding water condition is best corrected during a re-roof project. Outside of removing the existing insulation and starting with a new roof design, ponding water is difficult to correct.

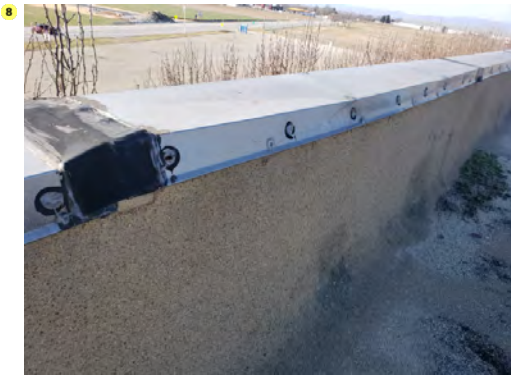
General - Coping/Wall Flashing loose (Remedial)

Coping is loose and is a danger to blow off and hurt someone.

We will properly re secure the loose coping and seal with NP-1 to ensure water tightness.

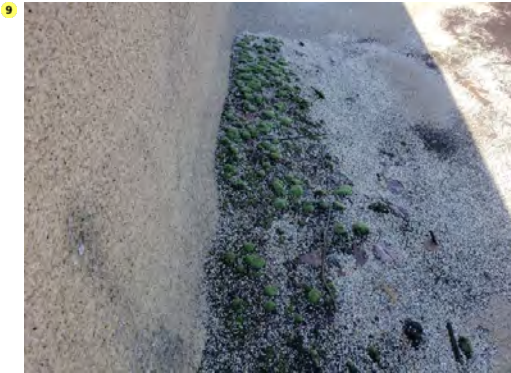
General - Vegetation (Remedial)

Vegetation growth on roof holds moisture on the roof which causes damage to the system over a period of time.

We will remove and dispose of the vegetation.

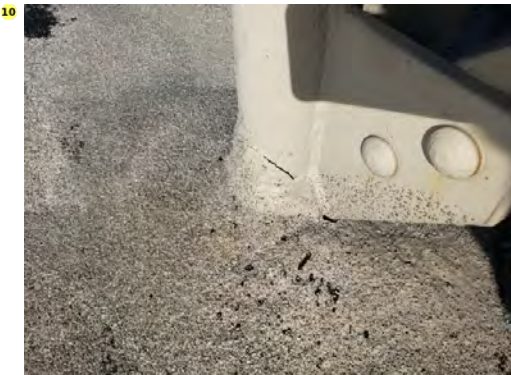
General - (Remedial)

Flashing open separating from support.

With this type of roof system there is nothing permanent we can do to patch the failing flashing. We can caulk with silicone which is a temporary repair.

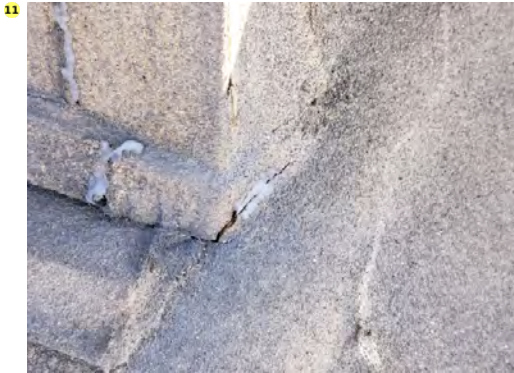
General - (Remedial)

Crack in foam roofing system.

With this type of roof system there is nothing permanent we can do to patch the failing flashing. We can caulk with silicone which is a temporary repair.

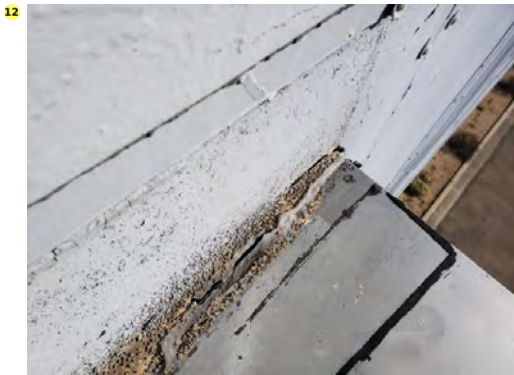
General - Coping/Wall Flashing Open (Remedial)

Coping joints are open and allowing water in.

Clean loose debris away and fill the caulk.

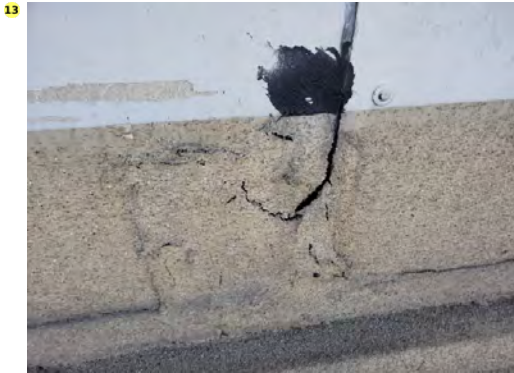
General - (Remedial)

Crack in wall flashing allowing water in the roof system.

With this type of roof system there is nothing permanent we can do to patch the failing flashing. We can caulk with silicone which is a temporary repair.

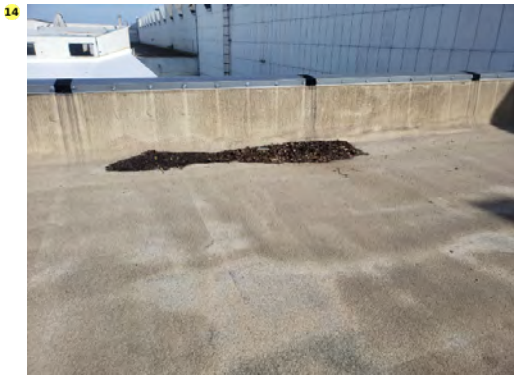
General - Debris (Remedial)

Debris on roof.

We will remove and dispose of debris.

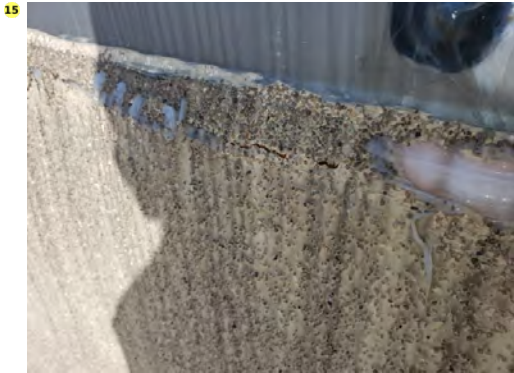
General - (Remedial)

Crack under coping in spots on wall flashing.

With this type of roof system there is nothing permanent we can do to patch the failing flashing. We can caulk with silicone which is a temporary repair.

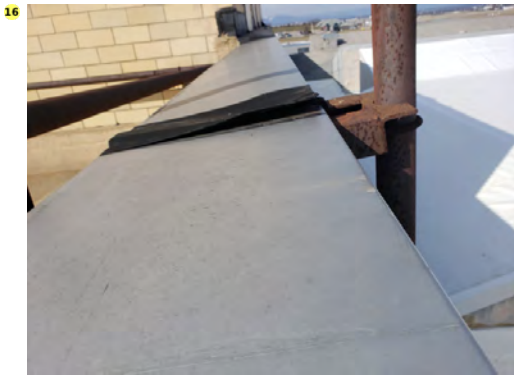
General - Coping/Wall Flashing Open (Remedial)

Coping joints are open and allowing water in.

We will remove loose flashing, clean, prime and patch the seam in the coping with new flashing.

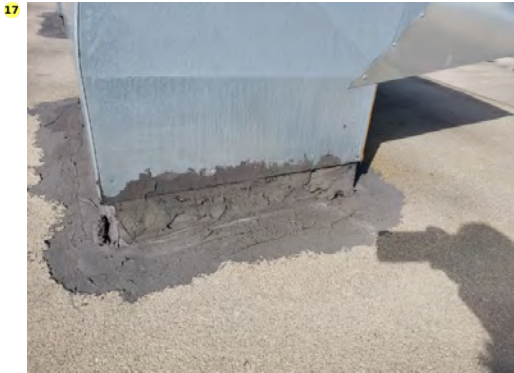
General - (Remedial)

The three course of roof cement is failing allowing water in the roof system.

Remove loose material and clean. Install new three course of roof cement.

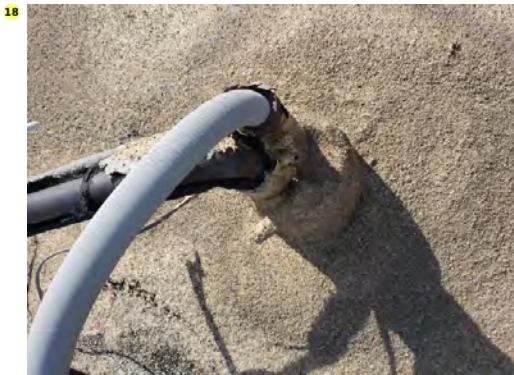
General - (Remedial)

The spray foam roof coating system is cracking and pilling allowing water into the roof system.

With this type of roof system there is nothing permanent we can do to patch the failing flashing. We can caulk with silicone which is a temporary repair.

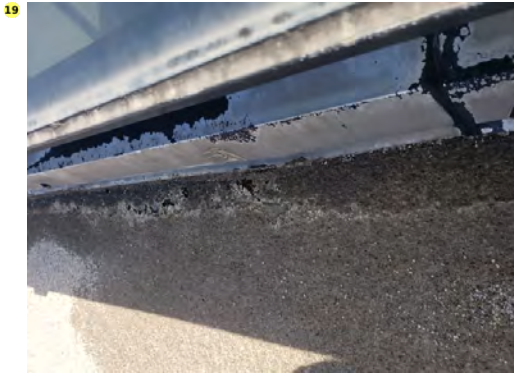
General - (Remedial)

There is cracking in the flashing around the skylight allowing water into the roof system.

With this type of roof system there is nothing permanent we can do to patch the failing flashing. We can caulk with silicone which is a temporary repair.

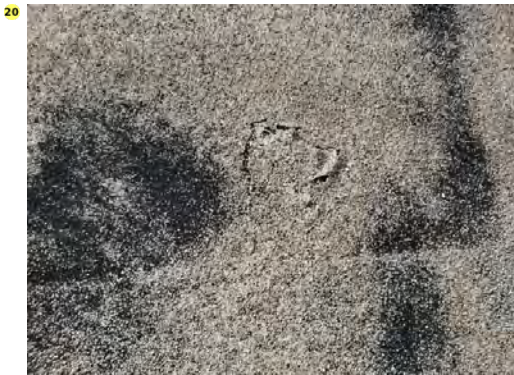
General - (Remedial)

Punctures and/or erosion allowing water in the roof system.

With this type of roof system there is nothing permanent we can do to patch the puncture/erosion. We can caulk with silicone which is a temporary repair.

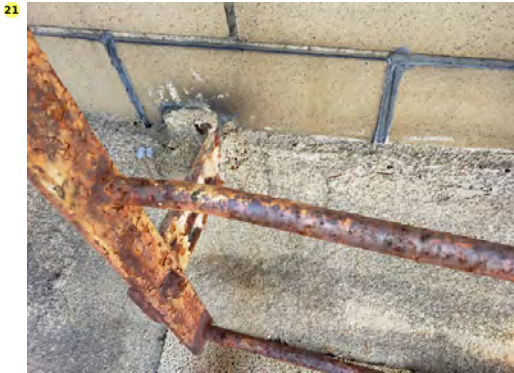
General - (Remedial)

Punctures and/or erosion allowing water in the roof system.

With this type of roof system there is nothing permanent we can do to patch the puncture/erosion. We can caulk with silicone which is a temporary repair.

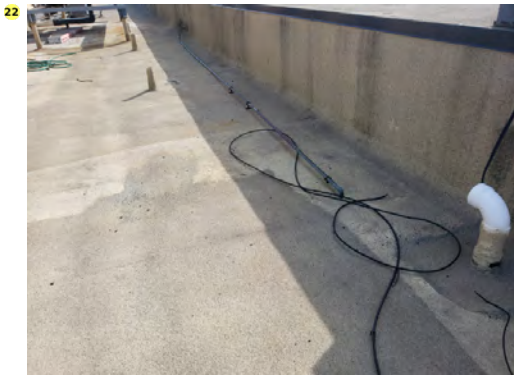
General - Debris (Remedial)

There is loose debris on the roof that could cause damage to the roof.

We will remove and dispose of debris properly.
