Management Report

Site Overview

Total Sections: 1
Total Sq/Ft: 60,103

Inspection Date: 02/24/2020

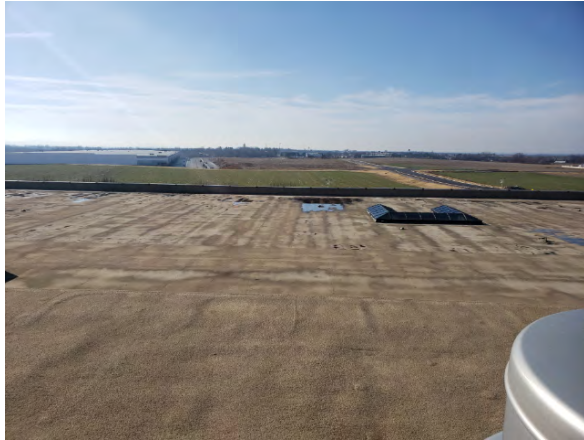
South overview

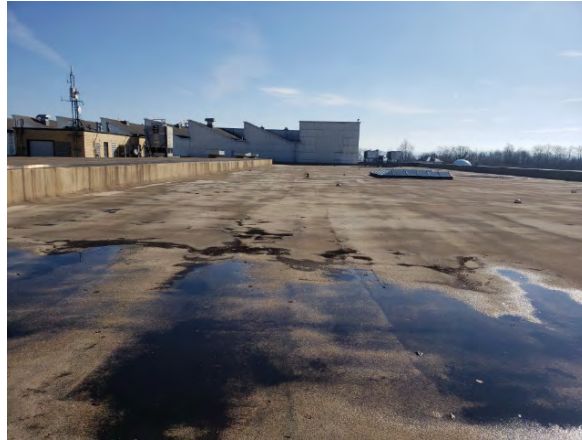
East overview

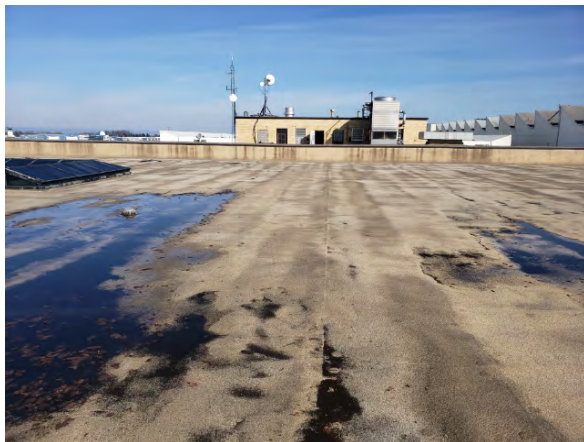
North overview

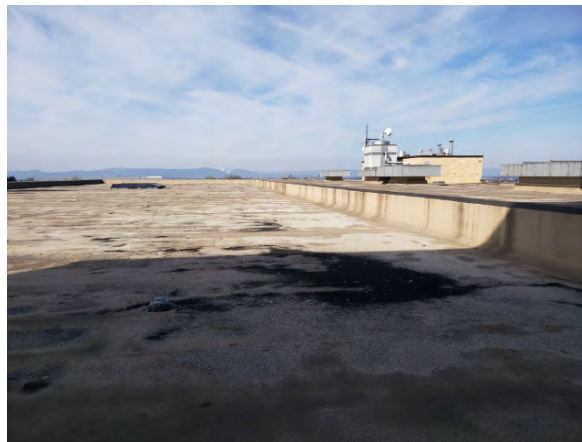
West overview

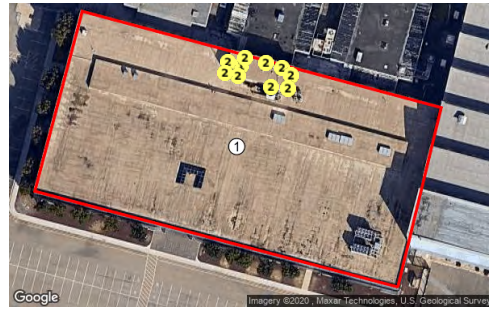
General - (Remedial)

Punctures and/or erosion allowing water in the roof system.

With this type of roof system there is nothing permanent we can do to patch the puncture/erosion. We can caulk with silicone which is a temporary repair.

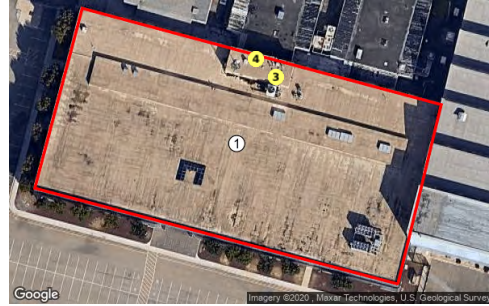
General - Debris (Remedial)

Debris on roof. It is recommended that you do not have debris loosely laying around on the roof without slip sheets or being tied down. They could cause damage or injure someone.

Remove debris off roof and dispose of properly.

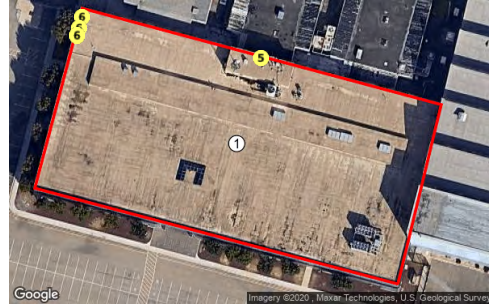
EPDM - Coping / Wall Flashing Open (Remedial)

Coping joints and wall flashing is open allowing water into the system.

We will clean and seal open coping joints and wall flashing. You would need to utilize ladders, ladder jacks and a walk plank to do this repair. As well as a lift to get tools and material on the roof. The men will have to be totally tied off per MOSHA.

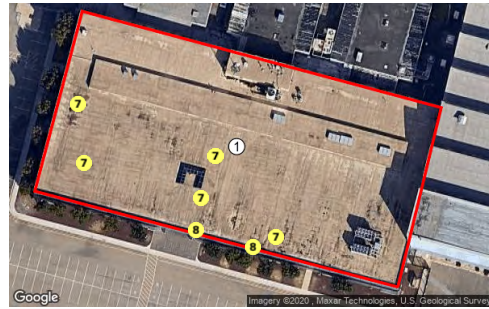
General - Ponding (Remedial)

A ponding water condition is typically due to a flaw in how the original roof was designed to flow to drains or the underlying insulation has collapsed due to age or weight and created a low lying area on the roof which is now holding water.

A ponding water condition is best corrected during a re-roof project. Outside of removing the existing insulation and starting with a new roof design, ponding water is difficult to correct.

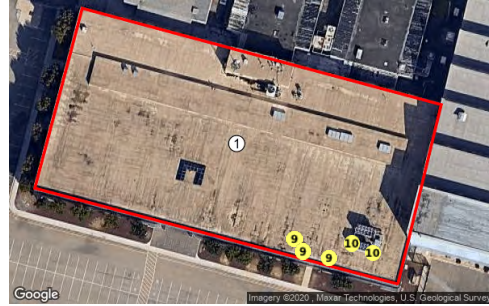
General - Vegetation (Remedial)

Vegetation growth on roof holds moisture on the roof which causes damage to the system over a period of time.

We will remove and dispose of the vegetation.

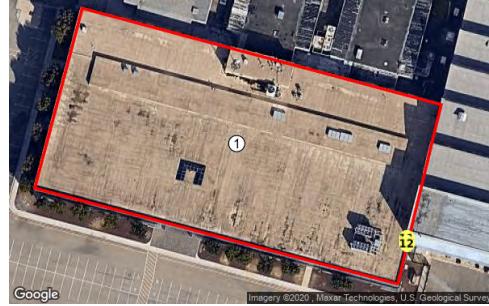
Crack in foam roofing system.

With this type of roof system there is nothing permanent we can do to patch the failing flashing. We can caulk with silicone which is a temporary repair.

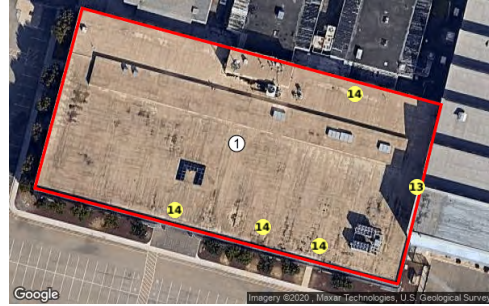
Crack in wall flashing allowing water in the roof system.

With this type of roof system there is nothing permanent we can do to patch the failing flashing. We can caulk with silicone which is a temporary repair.

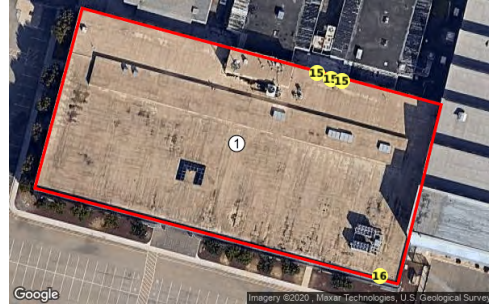
Crack under coping in spots on wall flashing.

With this type of roof system there is nothing permanent we can do to patch the failing flashing. We can caulk with silicone which is a temporary repair.

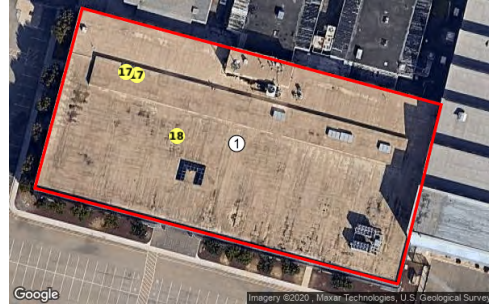
The three course of roof cement is failing allowing water in the roof system.

Remove loose material and clean. Install new three course of roof cement.

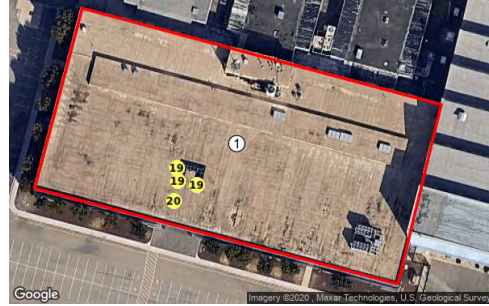
There is cracking in the flashing around the skylight allowing water into the roof system.

With this type of roof system there is nothing permanent we can do to patch the failing flashing. We can caulk with silicone which is a temporary repair.

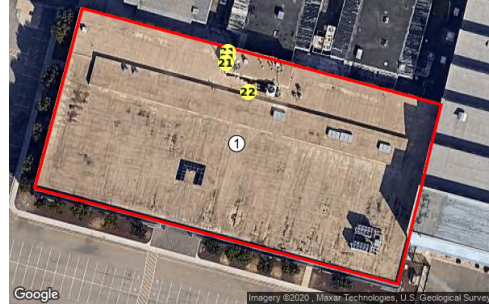
General - (Remedial)

With this type of roof system there is nothing permanent we can do to patch the puncture/erosion. We can caulk with silicone which is a temporary repair.
